Rethinking Montfort

Some Thoughts and Reassessments on the Architectural Evolution of the Castle after a Decade and a Half of Research

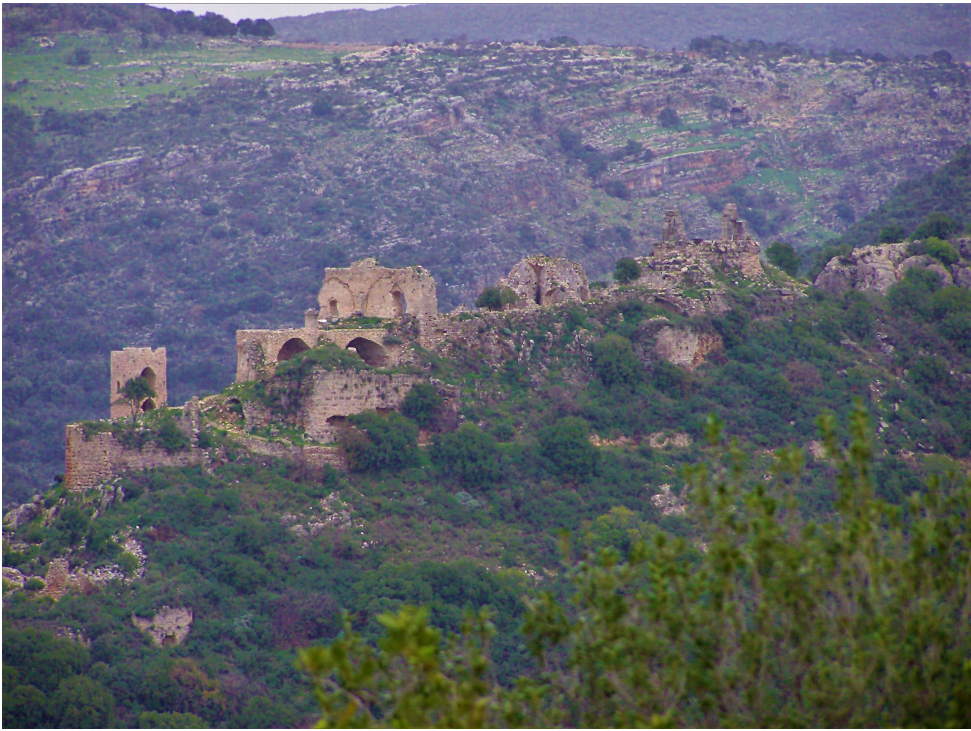
Fig. 1: General view of Montfort Castle in the western Galilee (© Adrian Boas and Rabei Khamisy).

Archaeology indeed has the capability of entirely changing our appreciation of the form, function, and history of a site. Nine seasons of excavations at Montfort Castle (fig. 1) in the western Galilee have abundantly demonstrated this. Through our fieldwork it has become apparent that much of what was understood prior to the application of the spade was imprecise, and more often than not, wholly erroneous.⁵ For here too, destruction

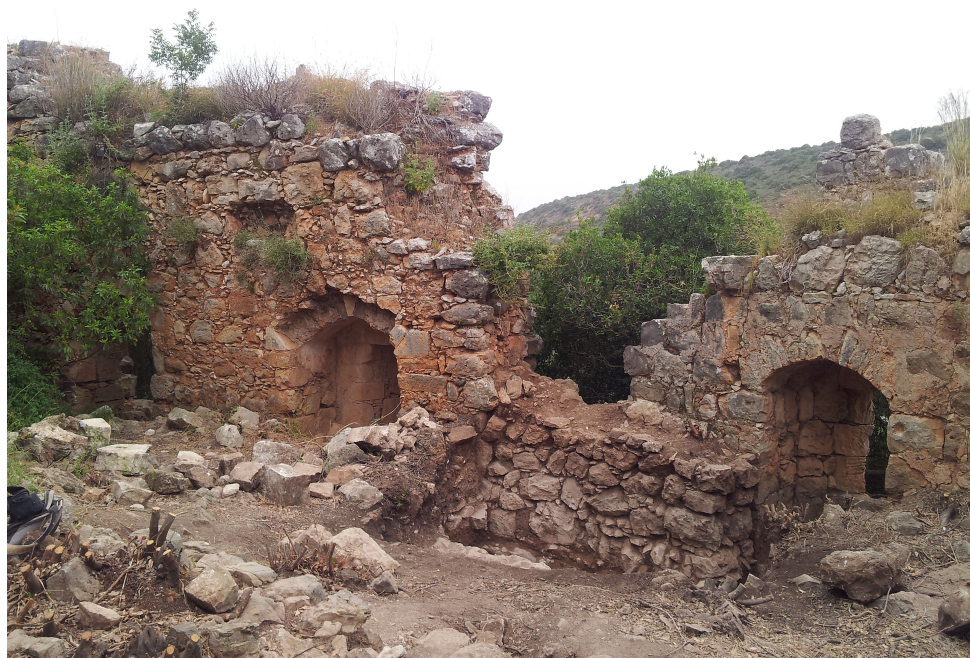
Fig. 3: Temporary wall blocking the space between the old outer wall and the new one (© Adrian Boas and Rabei Khamisy).

partly blocked the opening (fig. 3). It was noticed that the two sections of wall were quite different in construction, that to the south being thicker, of better construction and almost twice the height of the wall extending to the north. The northern section was preserved to its full height including its wall-walk and crenelation, whereas the southern section, although not preserved to its full height, was several metres higher, and the base of an arrow slit at its top shows that it originally stood at least two metres higher still. The hastily constructed blockage between the two sections suggests that the higher wall was under construction at the time when the castle came under siege, and that this necessitated a hurried, temporary construction in order to join the new replacement wall to what remained of the older one. There are two possible interpretations for the construction of the new wall. One is that at some point in time it was deemed necessary to replace the outer fortification wall which, although not very old was no longer considered strong enough to defend the castle. The other possibility is that damage caused during

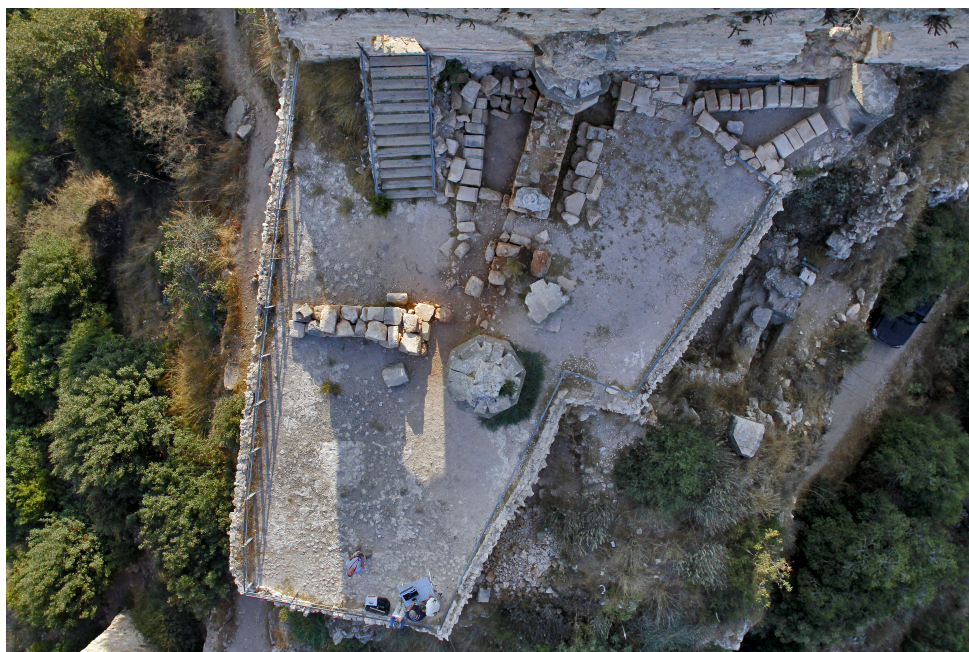
Fig. 4: Remains of the Great Hall (© Adrian Boas and Rabei Khamisy).

pilasters around the side walls (fig. 4). It may perhaps be regarded as an architectural prototype for the slender-columned gothic halls found in later Teutonic castles in the West, such as the summer refectory at Marienburg (Malbork), Poland. The vaulting in the Great Hall and the chambers above it (as indeed the chambers of the upper storey of the adjacent domestic building), were decorated with exquisite keystones with deeply carved bosses featuring foliate motifs in the form of leaves arranged in various patterns. Other fragments of similar foliate decoration from capitals and various architectural elements were also found in 1926 and in 2011.

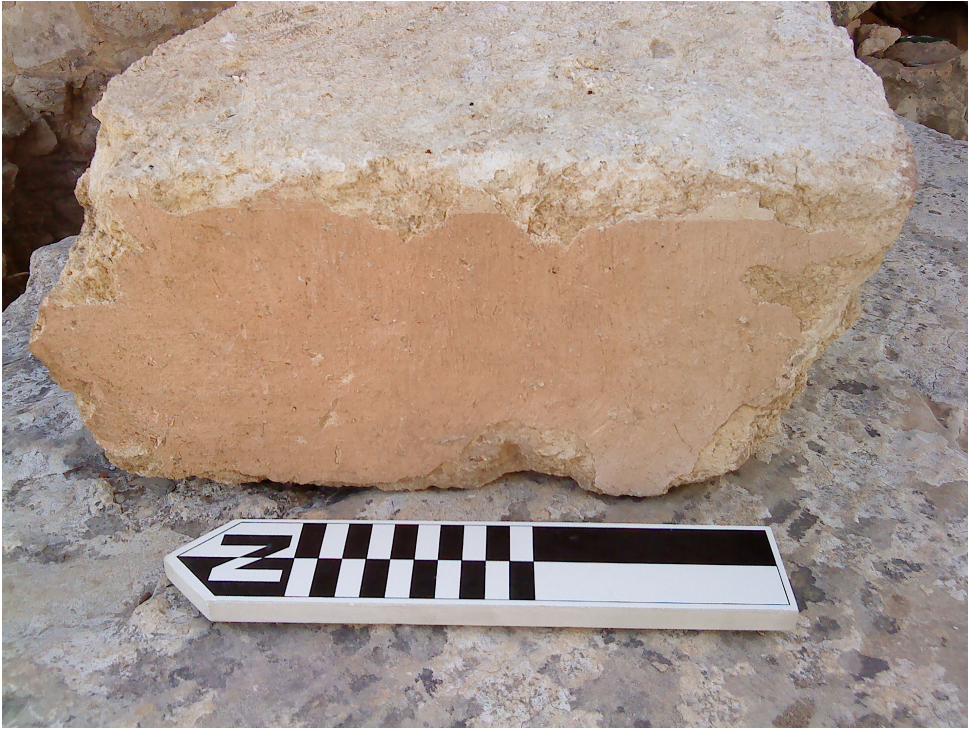
The walls of the Great Hall and the upper apartments were decorated with wall painting. This was not true fresco painting, but fairly simple painted decoration carried out on dry plaster and in some cases directly on stone. The degree of damage caused to these buildings in 1271 was such that these decorations were found in highly fragmentary form, mostly as tiny fragments scattered in the debris. The decoration was simple, mainly geometric, and mostly of pale yellow or salmon colour (fig. 5). There was also moulded plaster, again displaying simple geometric designs. Some of the fragments display painted lines in white on the coloured ground. Not enough of this material was recovered to

Fig. 5: Fragments of the painted decoration (© Adrian Boas and Rabei Khamisy).

enable a reconstruction of the decorative scheme. Several of the rib segments of both storeys displayed a mustard-coloured paint. In the 1926 excavations, rib-stones were found painted with designs in red, black, and ochre. These consisted of stripes, in one case foliate motifs and in another a large *fleur de-lis* outlined in black with a ochre background.

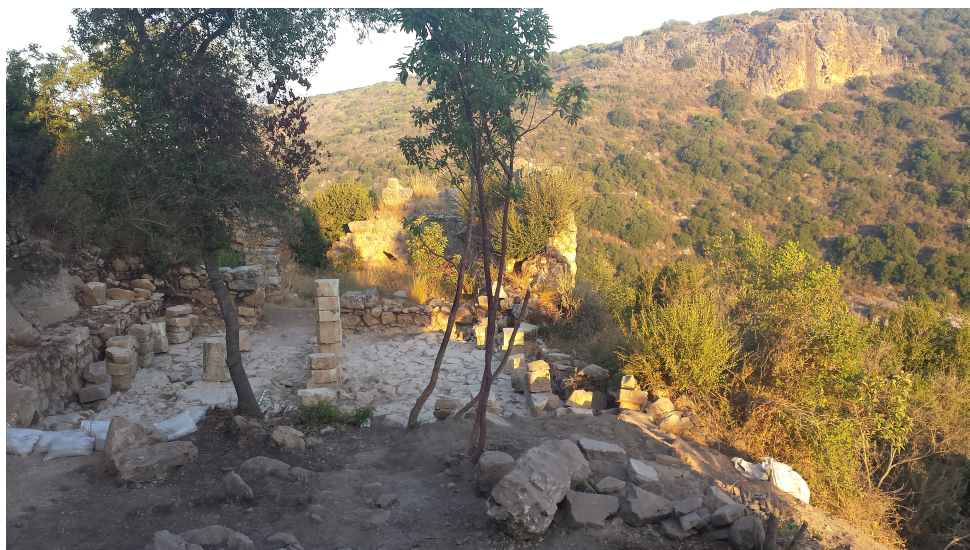
Fig. 7: The stables (© Adrian Boas and Rabei Khamisy).

In two excavation seasons in 2014 and 2015 a large stable complex was identified in the lower ward on the north near the north-west corner of the outer fortifications and directly adjacent to the small gate on its east. This was an appropriate location, as travellers arriving at the castle would have been able to deposit their horses and mules in the stables here before proceeding up a path to the upper gate tower where they would enter the main part of the castle. The excavations exposed a large, roofed chamber running adjacent to the fortification wall. It was paved partly with natural rock and partly with large flagstone pavers. The roofing was supported by wooden beams held on protruding

stone corbels on the fortification wall and there would have been putlog holes, or perhaps corbels, on the inner wall as well. Because of the width of this building, wooden beams of sufficient length to cover the entire span could probably not have been obtained, and so an additional support apparatus of double arches on central piers was constructed, the arches springing from the fortification wall on the northern side and from a rock-cut ledge or platform on the south (fig. 7). A row of mangers was constructed at appropriate height for horses along this ledge between the arch springers. Along the centre of the chamber a row of six free-standing columns supported the arches and, in turn, the roofing beams. There may have been water troughs or additional mangers between the columns. Fragments of the roofing beams, carbonated and poorly preserved, were found along with, numerous large carpentry nails.

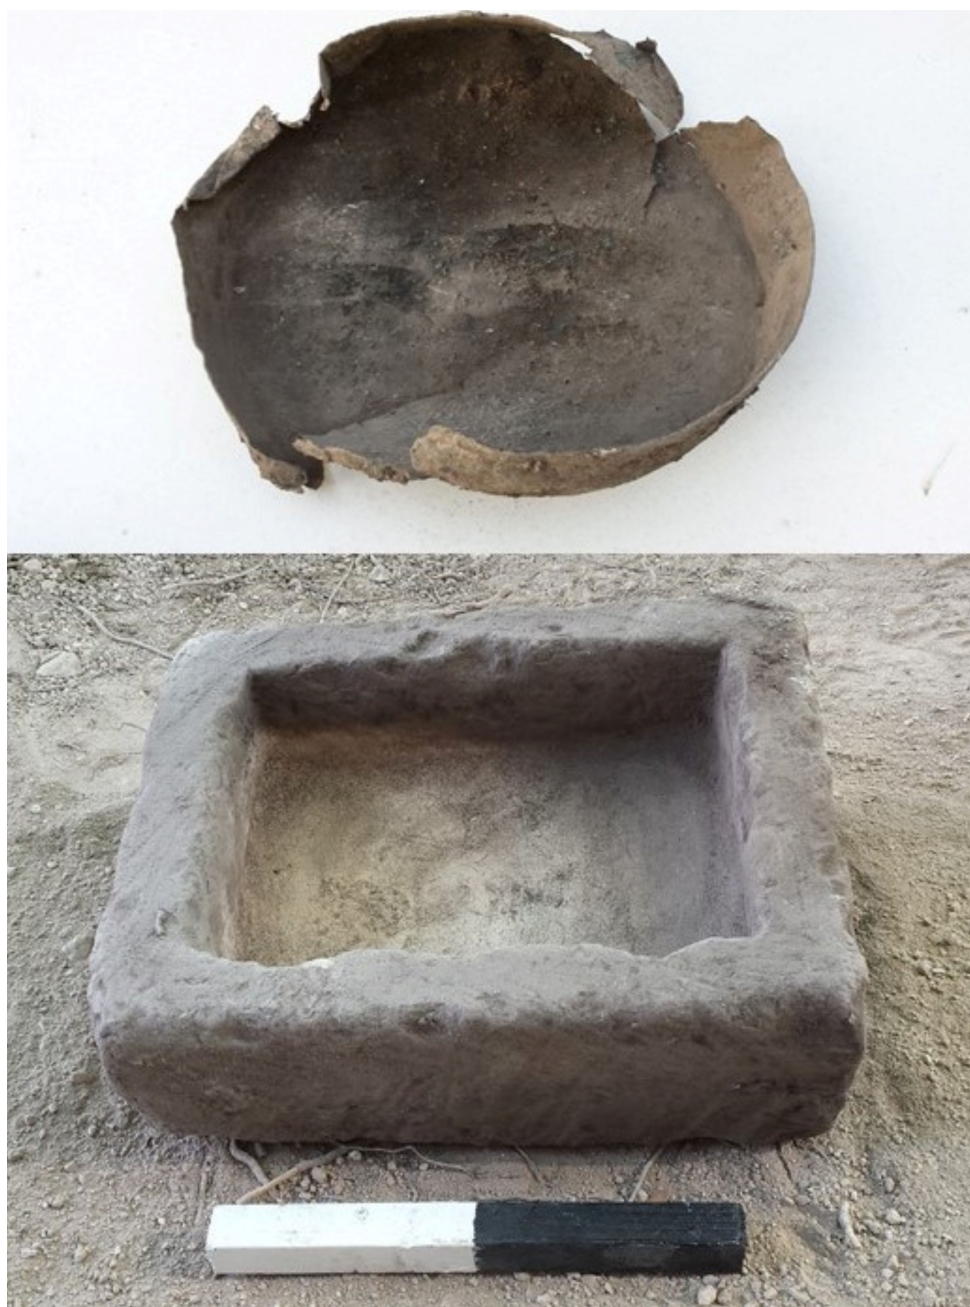
At the centre of the eastern end of the chamber were a number of areas of accumulation of ash and reddish clay. This appears to have been a work area. Two large bronze pans were found here, along with a small bronze bowl and well-formed rectangular stone basin, possibly a crucible, and a great deal of very fine ash, suggesting that this area served perhaps as a smithy (fig. 8). There was also a small quadrangular shaped walled-off area, perhaps used to steady a horse during shoeing.

Fig. 8: Vessels found in the stables (© Adrian Boas and Rabei Khamisy).

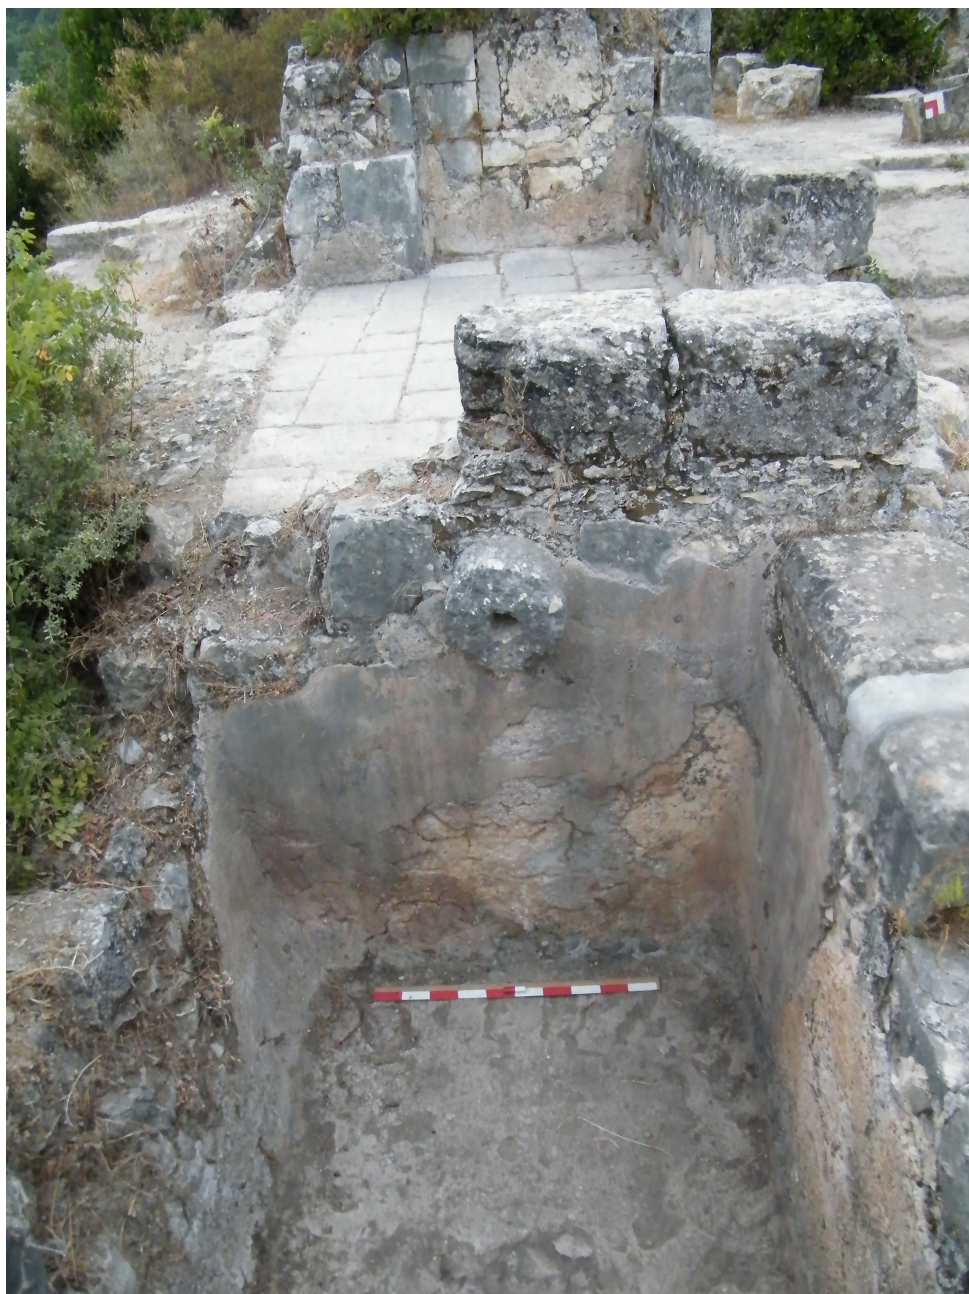
Fig. 9: The winepress (© Adrian Boas and Rabei Khamisy).

A large winepress (fig. 9) was exposed in 1926 and during the 2011 season of the current project was re-examined.¹² Located just inside the central domestic ward of the castle, it consisted of two elements: a treading floor and collecting vat with a large stone pipe connecting the two. The installation is slightly irregular, in shape, with the treading-floor paved with neatly laid rectangular slabs, sloping slightly towards the pipe. The walls and floors and collecting vat are covered in hydraulic plaster containing small pieces of pottery. A round sump in the floor of the vat assists in collecting the grape juice after the first stage of fermentation, that, according to the study took place in the vat itself. The wine produced in this large installation was certainly for consumption within the castle, where, as in all military order or monastic houses, drinking of wine took place daily at compline. Wine could also be supplied to the castle from local villages and perhaps from the recently discovered large wine installation outside the order's castle at Mi'iliya, but a winepress within the castle may have become particularly necessary during the last five years of Teutonic occupation of Montfort, when the Frankish controlled territory around the castle was probably abandoned following the siege of 1266. It is perhaps possible that the winepress was built at this time in order to make up for a loss of the local wine suppliers (although grapes, along with other supplies, would still have had to be brought in from further afield).

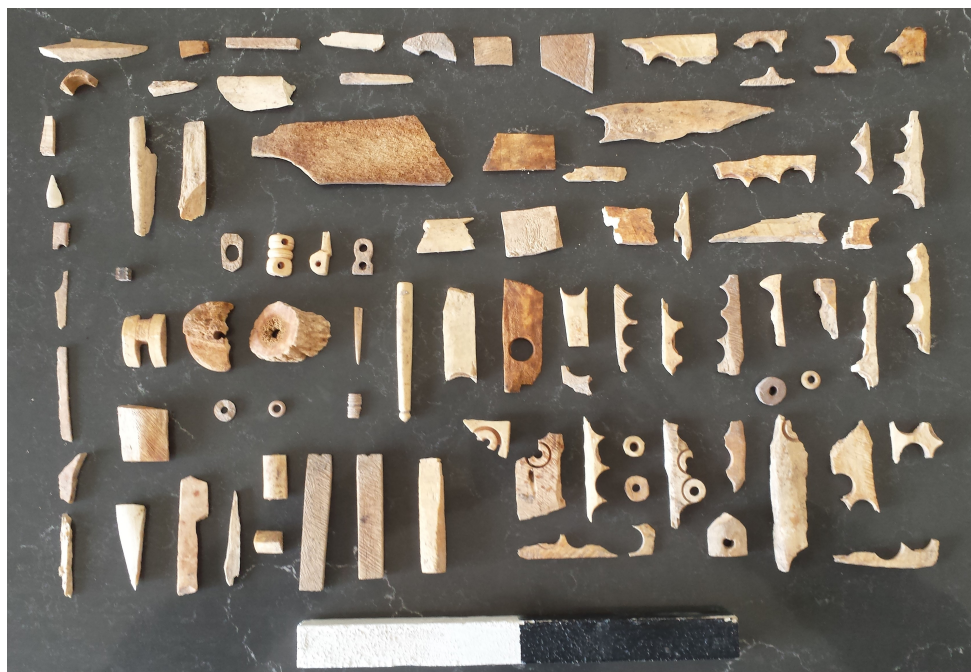
Fig. 10: Bone objects found in 2016 (© Adrian Boas and Rabei Khamisy).

Several finds of worked bone were found in various parts of the castle in 1926 and among these were some that hinted in local production, notably objects of raw material, such as a boar’s teeth, and various worked objects including cut bone disks with drilled holes, a number of small, thin, cut pieces of bone, perhaps inlays for furniture or other wooden objects, crossbow nuts (part of the crossbow mechanism), and bone rings. Evidence for a bone industry was found near the southwest gate where nearly 100 pieces of worked bone, including such items as buttons, toggles, handles and crossbow nuts, as well as several pieces of bones from which such items had been cut, were found, along with pieces of cut horn (fig. 10).

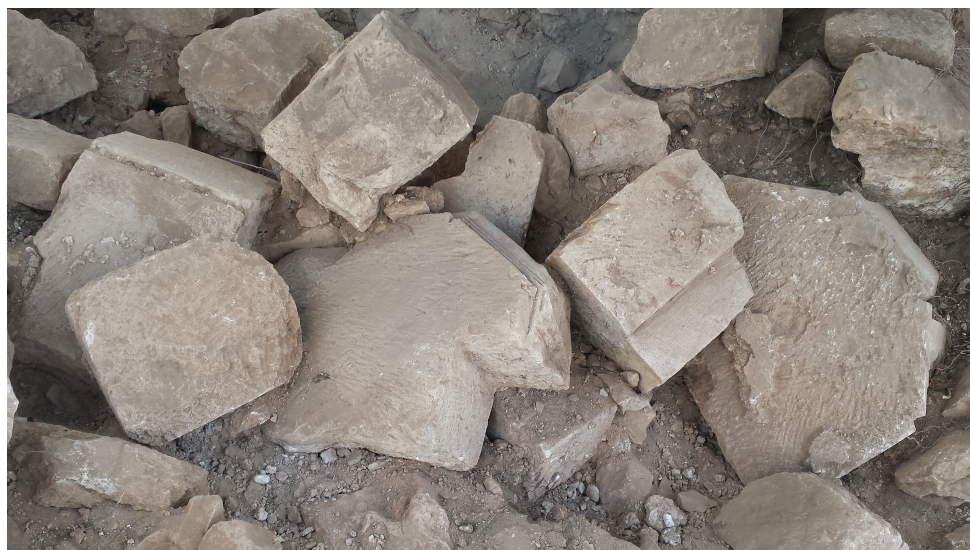
Fig. 11: Fallen remains of the interior architecture of the newly discovered hall (© Adrian Boas and Rabei Khamisy).

observed that some sort of structure extended west of the administrative building and a large part of a plastered cistern vault survived here as well as remnants of a wall attached to the exterior of the administrative building. A section of the western wall of the cistern also survived, two metres thick, well-constructed and preserved to a height of over three metres. Nothing, however, was known of the function of the structure that once stood here and no reference had been made to it in any previous publication. The excavations were carried out just beyond this structure to its west, between it and the curved defensive wall attached to the gate tower. These exposed a layer of debris consisting of a large quantity of architectural elements of monumental size. Among these were chamfered rib sections, part of a half-octagonal pier, a decorated cornice, and a *tas-de-charge* (fig. 11). In addition, large sections of plaster flooring and a few pieces of grisaille-decorated stained glass were recovered. All of the architectural elements are similar to those of the vaulting in both the central domestic building and the two levels of the administrative buildings, but they could not have originated in either of those as their proportions are somewhat different. In fact, what was exposed here was the remains of yet another ceremonial hall that originally stood above the above-mentioned cistern. The architectural pieces were recovered as they had fallen when the building was undermined, and indeed as they had once stood in the lost hall about sixteen metres above – pier, cornice, *tas-de-charge*, and ribs. The hall had

been approximately half the size of the Great Hall, consisting of two rib-vaulted bays with half-octagonal pilasters in the middle of its north and south walls. Its walls were about 2 metres thick. When it was brought down by Mamluk undermining after the castle fell, most of it had collapsed down the southern slope, but a large part of it had fallen into this area adjacent to the curved wall, and so was preserved and exposed in the excavations. On observing more closely the other surviving walls of this building we noted that, as opposed to our initial thoughts, it in fact predated the administrative building, and that the latter had been attached to it. It appears that originally this two-storey building was a free-standing structure, and only later was joined to the buildings to its east when the administrative building was built between it and the domestic building further to the east.

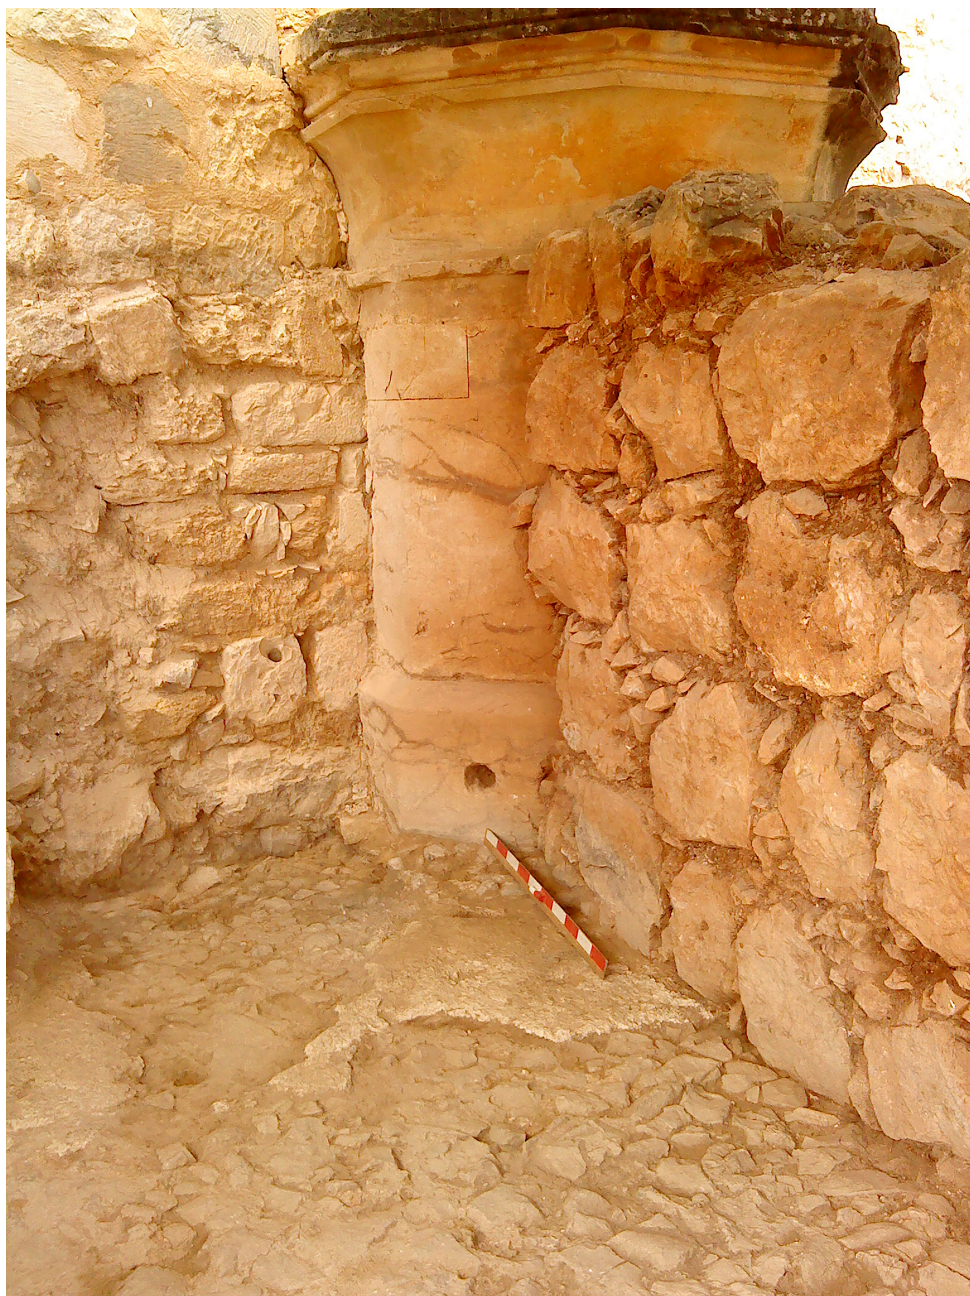
Fig. 12: Temporary support wall in the ruins of the Great Hall (© Adrian Boas and Rabei Khamisy).

The first efforts of the garrison would have been to contain the damage and prevent further collapse. Perhaps the best evidence for this was uncovered in the first excavation season in the summer of 2011. During excavations in the remains of the Great Hall a wall was exposed (fig. 12). Although massive (1.2 metres thick), it had been constructed

of large, roughly shaped fieldstones but with no mortar. Built over the already damaged floor and against a damaged pier, its construction shows that it was clearly not a structural wall, and it appears to have been built in order to prevent further collapse of the surviving vaulting. Presumably it enabled the area of the hall to continue to function in a limited manner. It is one of a number of efforts made by the garrison to recover after what was apparently major damage caused by the Mamluk siege machines in 1266. If it did not enable the reconstitution of the Great Hall to its former ceremonial function it did at least enable it to fulfil another purpose, that of housing livestock and perhaps carrying out butchery activity. Along with supporting the damaged hall, were several other works, some of a temporary nature, others of permanent work, that constituted large scale restoration efforts of internal structures and the castle's fortifications. Evidence suggests that the Germans believed that restoration of the castle would be possible, and that they took initial measures towards this end, measures that proved futile when Montfort fell to Baibars and was dismantled in 1271.

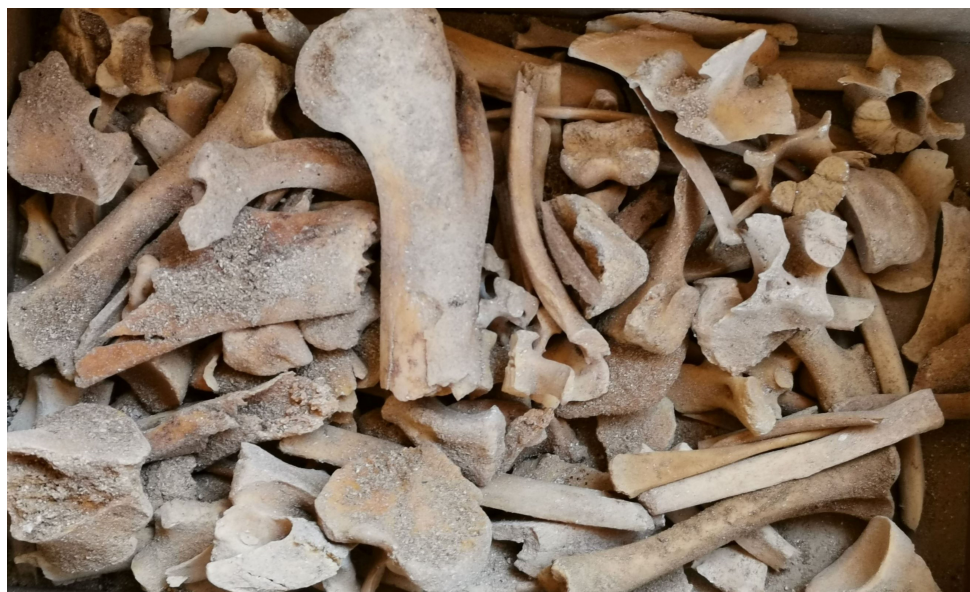
Fig. 14: Animal bones found in the collapsed debris from the Great Hall (© Adrian Boas and Rabei Khamisy).

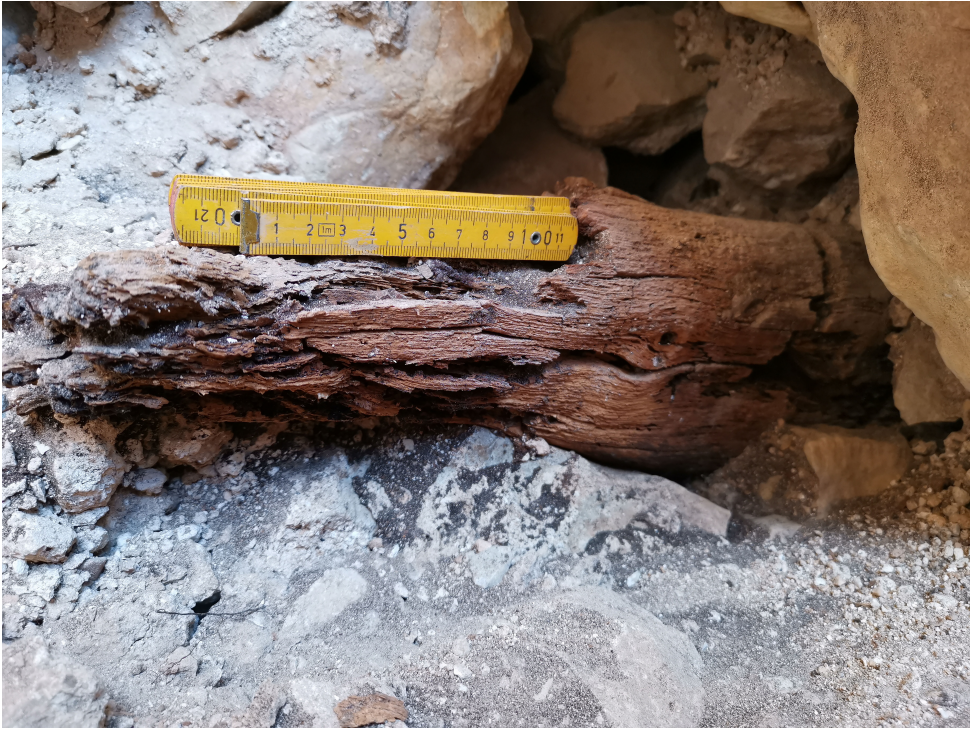
Fig. 15: Cut brushwood from the rubble in the western basement vault (© Adrian Boas and Rabei Khamisy).

have also been used for cooking, for in 2011 we found on the damaged floor a cooking pot, ash, and pig bones. Within the debris of the basement there was also a quantity of cut brushwood (fig. 15). This too may have fallen from the ruined hall point to it having been used to store firewood as well, although the brushwood may possibly have fallen from a wooden mezzanine within the basement vault. Also found in the lower debris of the basement was a quantity of carbonized grain, which may also have fallen from the hall above, or from the mezzanine.

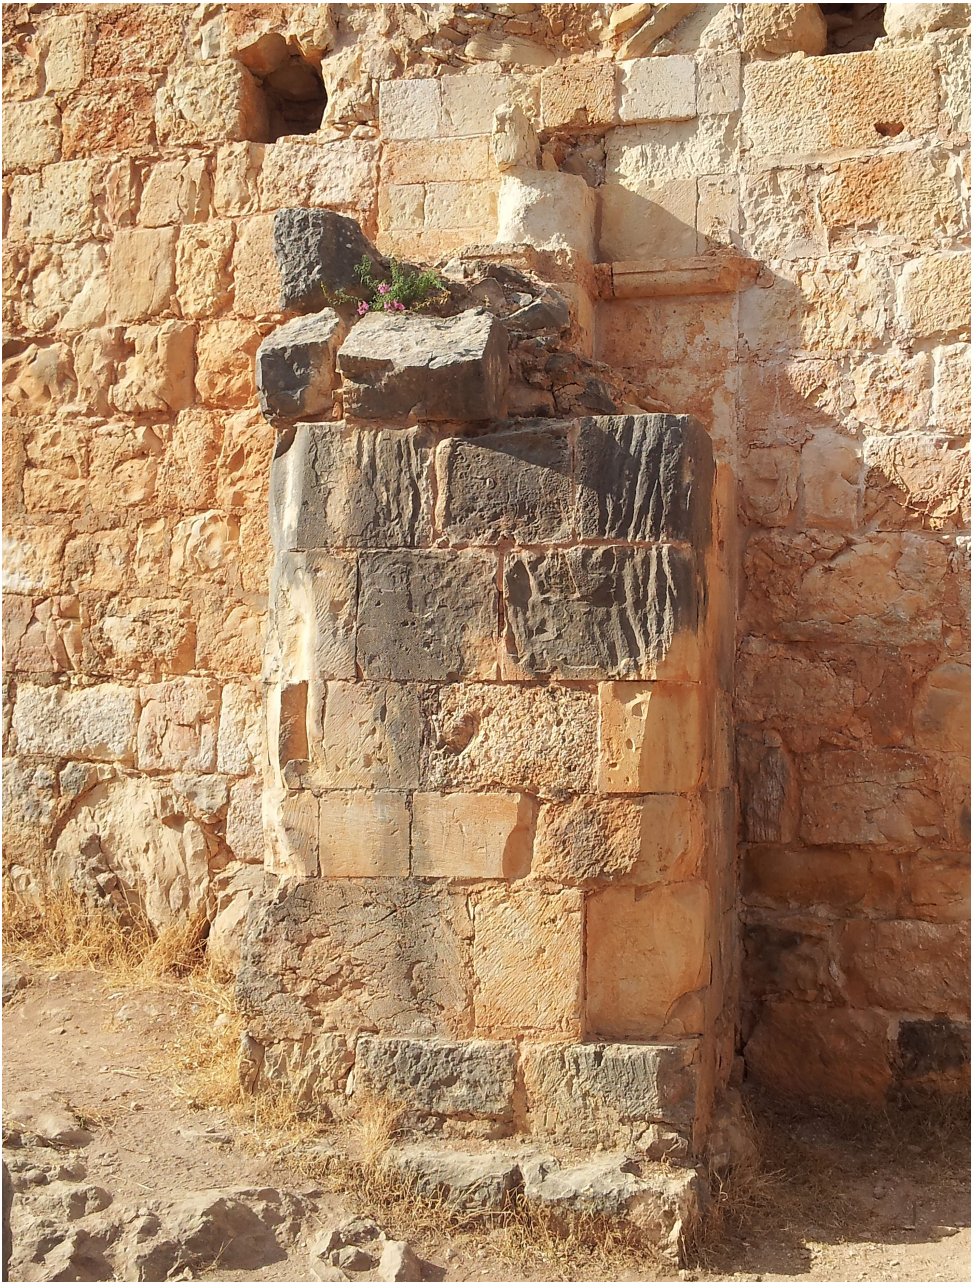
Fig. 16: Strengthening of the domestic ward structure (© Adrian Boas and Rabei Khamisy).

taken place. Perhaps here too the damage to the upper storey was substantial enough to warrant it being abandoned or only partly used. As the upper storey apparently served as the dormitory and refectory of the brothers, and perhaps contained the chapter house and other functional rooms, its loss would have necessitated a major functional realignment, with new quarters needed to be found for the brothers. How this was resolved we do not know, but a careful examination of the ground floor level clearly shows that, like the Great Hall, quite late in the life of the castle, this building underwent a major strengthening, indeed, a much more substantial one, with massive new walls constructed between piers, in some cases encasing the original structure in new thick masonry (fig. 16). Then, at least along one side (the south) of this elongated structure, lesser dividing walls were constructed, and a series of very small chambers was created. Their function is unclear at present, though in one a large, plastered shallow basin with an adjacent plastered channel was found, suggesting some type of industrial activity (fig. 17).

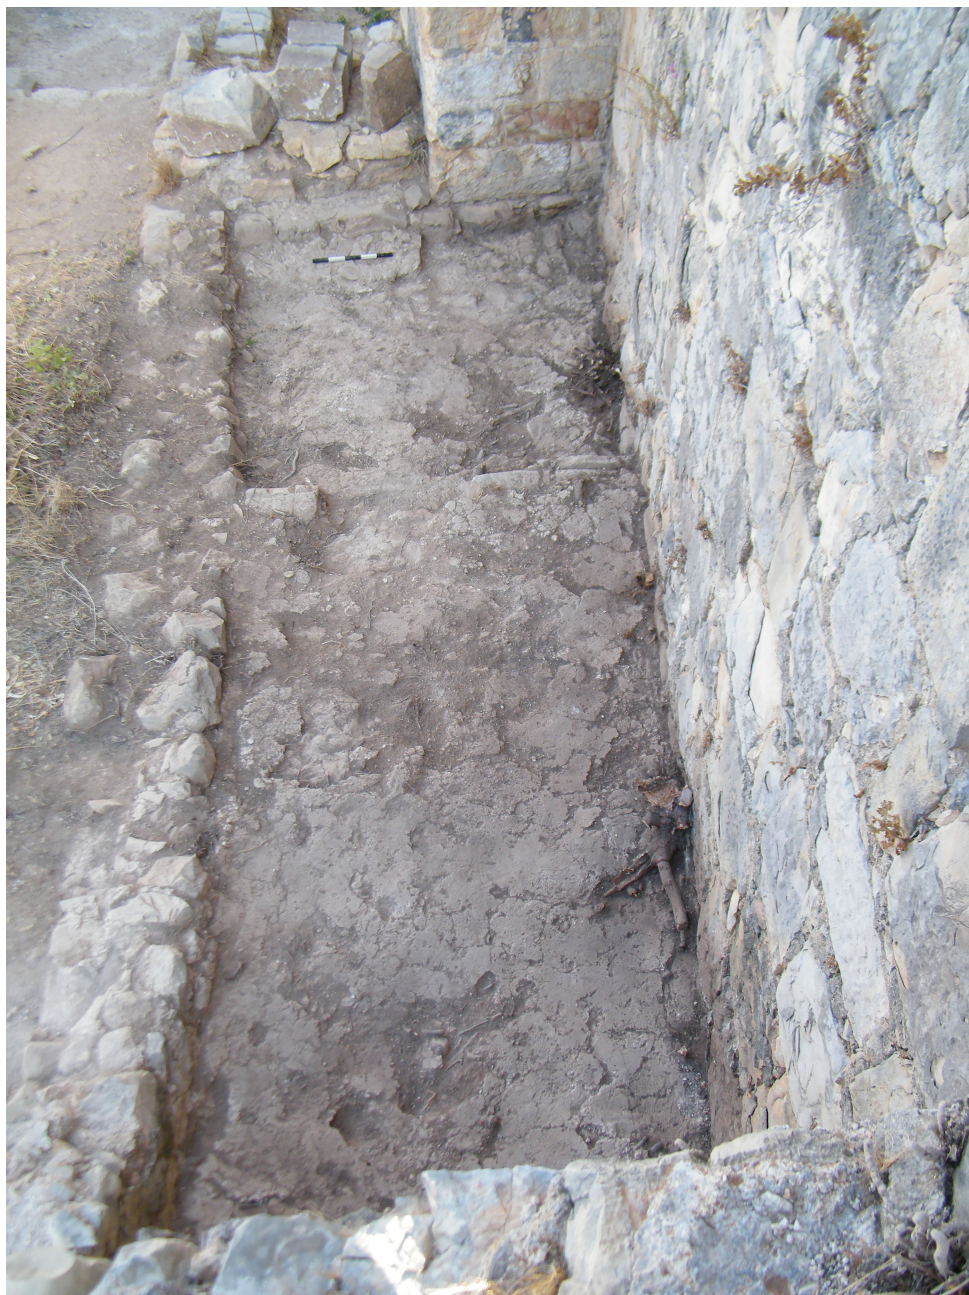
Fig. 17: Plaster basin in the domestic ward ground floor (© Adrian Boas and Rabei Khamisy).

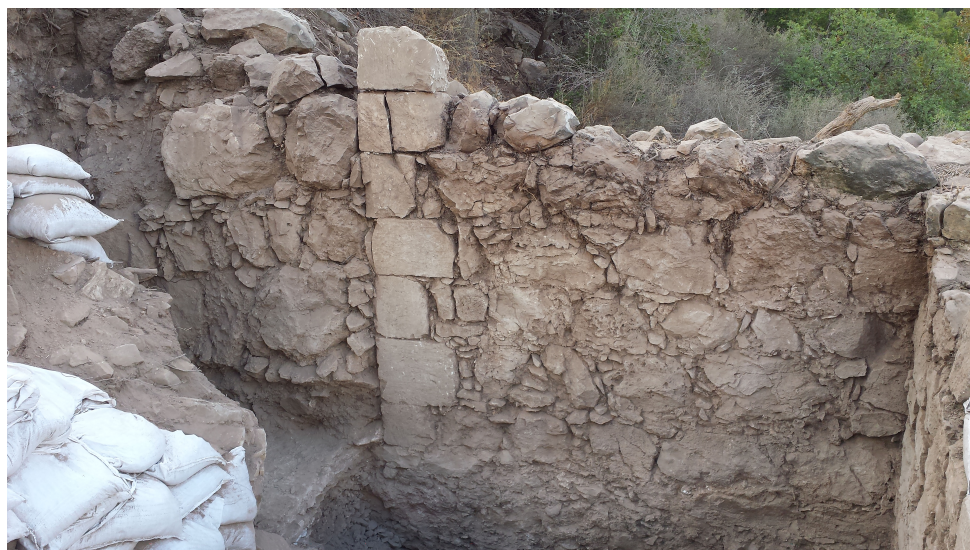
Fig. 18: Newly discovered blocked gate (© Adrian Boas and Rabei Khamisy).

An additional change of function was found in 2016 when, during excavations on the southwestern corner of the outer fortification wall, a blocked gate was discovered (fig. 18). Having gone out of use, and being blocked with stones and mortar, a plastered chute, possibly a sewage chute, was constructed against its outer face. The chute appears to have extended down the steep western slope from the buildings at the western end of the upper ward. A possible scenario for this is that after the damage caused in the siege of 1266 it was decided to block this gate, and some point of time during the remaining five years of the castle's life the chute was constructed.

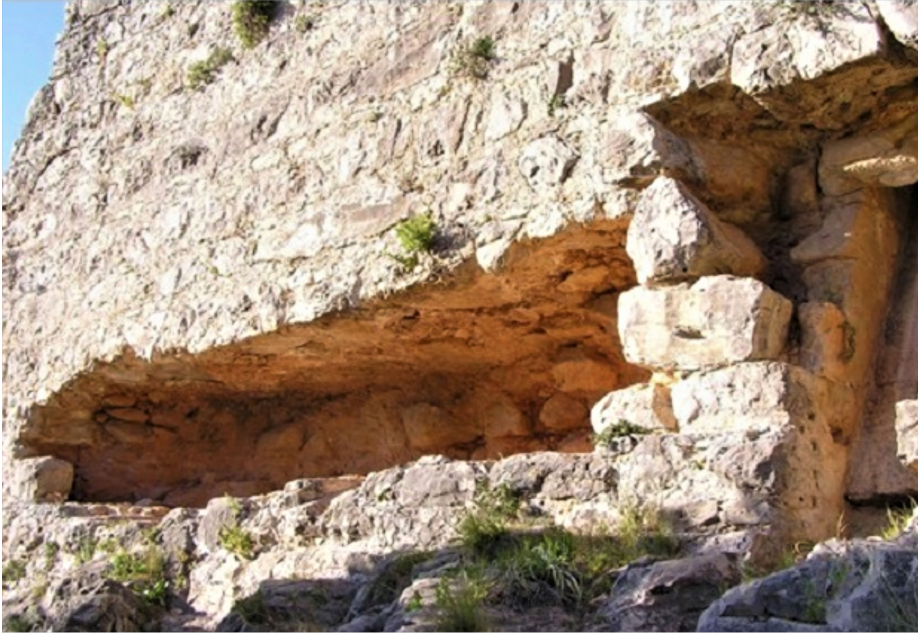
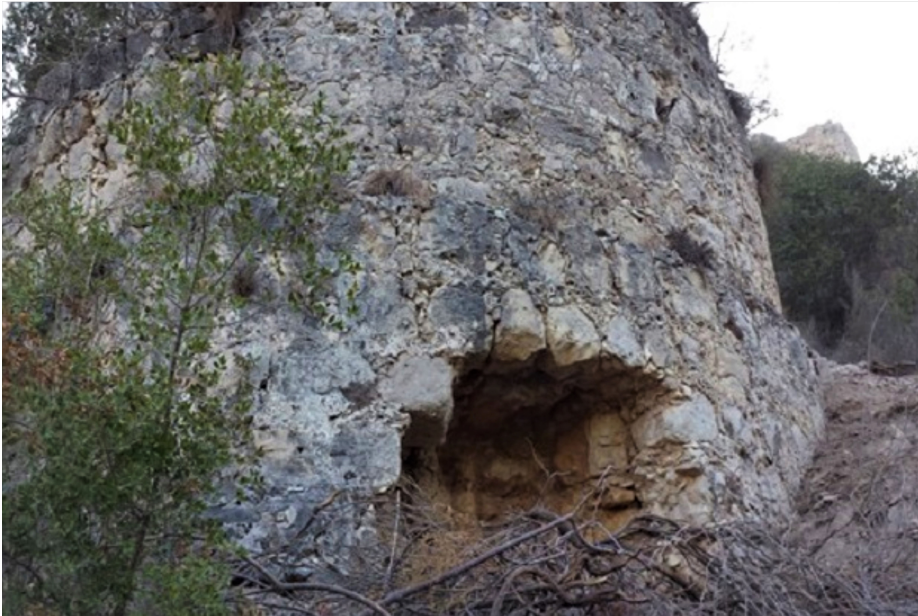
Fig. 19: Undermining of the administrative building (a) and the south-western tower (b) (© Adrian Boas and Rabei Khamisy).

At the base of the southern side of the administrative building is a support wall below the level of the basement vaults under the Great Hall. This wall is 5 metres thick. Along its length is a large cavity, one metre high, three metres deep and eight metres in length (fig. 19a). It appears to be the result of an unsuccessful attempt by the Mamluks at undermining the huge building either during the siege of the castle in the summer of 1271, or perhaps during the dismantling that took place after the castle fell. As there is a historical reference to Baibars offering payment to his soldiers for stones removed from a wall referred to as the „Sūr“, ¹⁴ this cavity may in fact be evidence for that episode and date to the siege itself. In any case, the undermining failed, apparently because this was not in fact a free-standing wall, as the besiegers presumably thought, but merely a layer of stonework covering the natural bedrock on the slope below the building and its removal consequently did not weaken the structure above but merely exposed the bedrock

beneath. The unfinished state of this undermining suggests that after considerable effort had been spent, the miners became aware of the futility of their efforts.

A second case of undermining was found when work was carried out on the round tower at the south-western corner of the outer fortifications. A large, roughly excavated cavity can still be observed today at the base of the tower (fig. 19b). Similar in appearance to the undermining below the Great Hall, it too appears to have been excavated below floor level into the foundations of the tower and, perhaps similarly into the bedrock, and therefore did not cause the collapse of the tower.

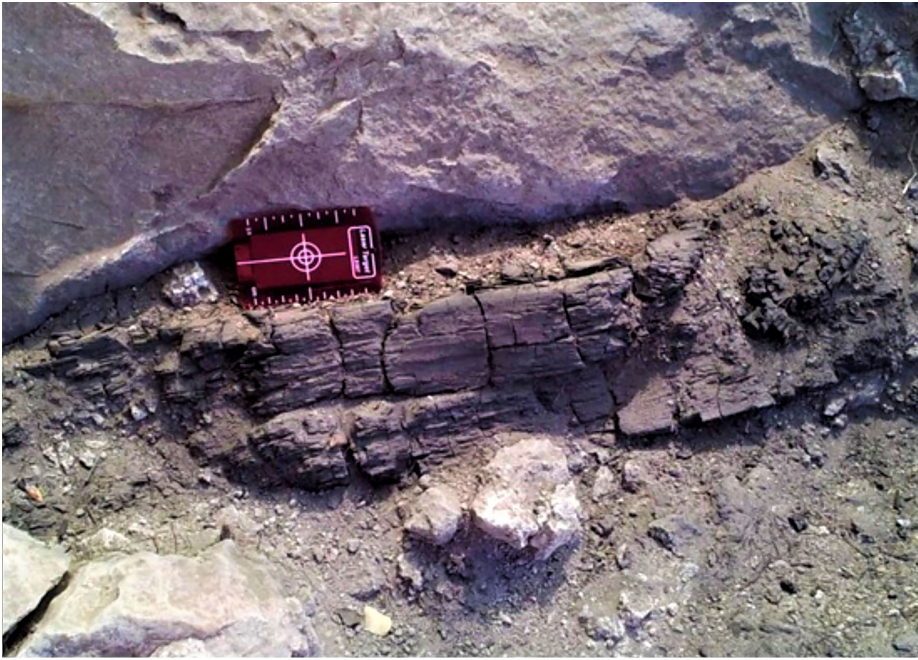
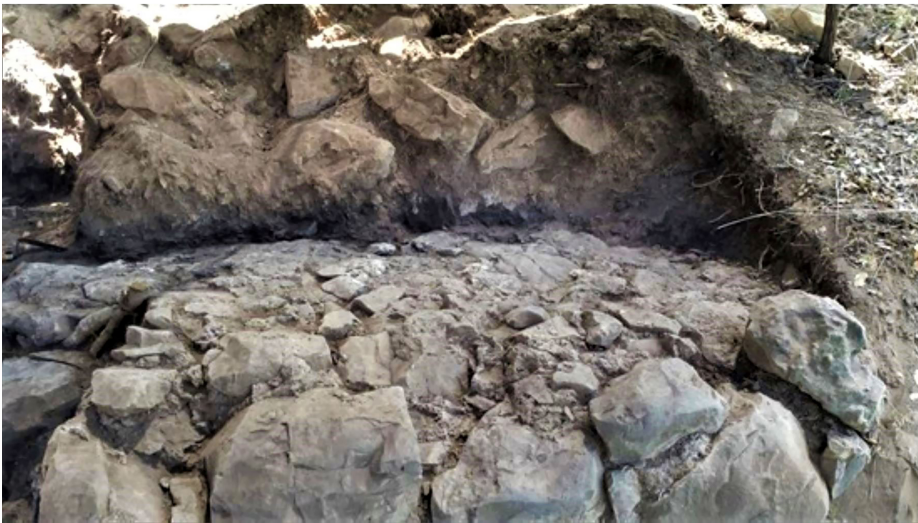
Fig.20: Undermining of the domestic building (a) and the westernmost building (b) (© Adrian Boas and Rabei Khamisy).

Other examples of undermining that most likely took place during the dismantling of the castle after its fall, were found on the northern wall of the domestic building and on the north-western corner of the westernmost building of the upper ward that was excavated in 2017. In the first of these, as a result of the sapping, the entire wall except for its base (about two metres high and three metres thick) had collapsed down the northern slope. Within the surviving base of the wall were found in 2013 several large pieces of burnt wooden beams. (fig. 20a) These had apparently been placed deep within a cavity excavated in the wall and then set alight, and, to judge from the fragmentary remains of this wall, had very successfully achieved their aim in bringing it down. In the second case the undermining, evidenced by a thick layer of ash above what remained standing of the building's western wall, was also successful in causing almost the entire collapse of the structure including the gothic hall on its upper level (fig. 20b).
